**Technical Report No. ENV-2023-101**

# **Lower San Acacia Reach: Geomorphology and Alternatives Description**

**Middle Rio Grande Project, New Mexico  
Upper Colorado Basin Region**

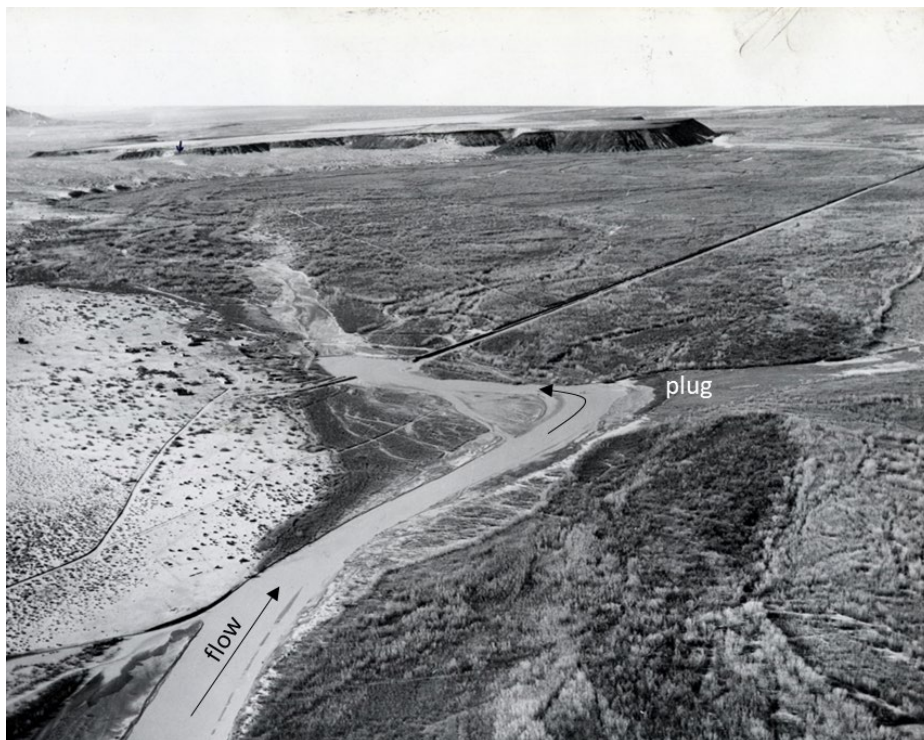
Figure 3.—Aerial photo from 1952 showing the river altering course due to the formation of a sediment plug within the San Acacia Reach above the Tiffany Basin. Low flows and dense vegetation prevented the river from cutting a new channel through the floodplain, losing surface flow connection in the upper left of the photo.

Perching is not a new phenomenon on the MRG, and the channel periodically become perched prior to the 1950s channelization. Historically, when the channel was perched high enough above the adjacent floodplain, the next flood event would cause an avulsion that moved the channel to a lower elevation (Massong et al. 2010). The river experienced high water losses during low flow years between avulsion-generating flood events (Figure 3). Avulsions have been limited since the 1950s because of lower peak flows, dense riparian vegetation, and channel and levee stabilization. Channel and floodplain perching has continued to increase without avulsions to periodically reset the river.

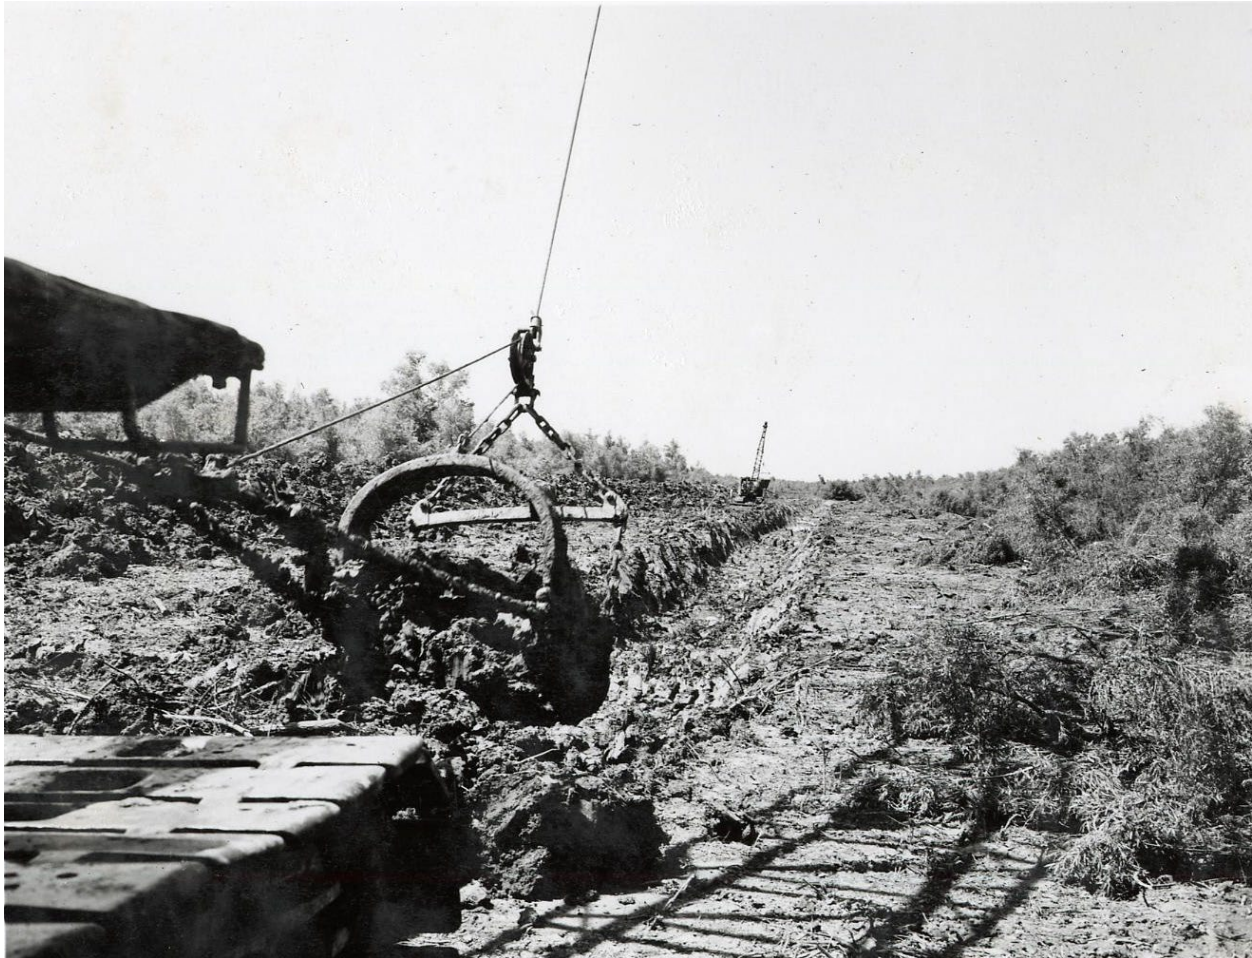
Figure 22.—Looking downstream at excavation of a pilot channel and construction of levee for diversion operations, July 1952 (Reclamation/Herman E. Carter).

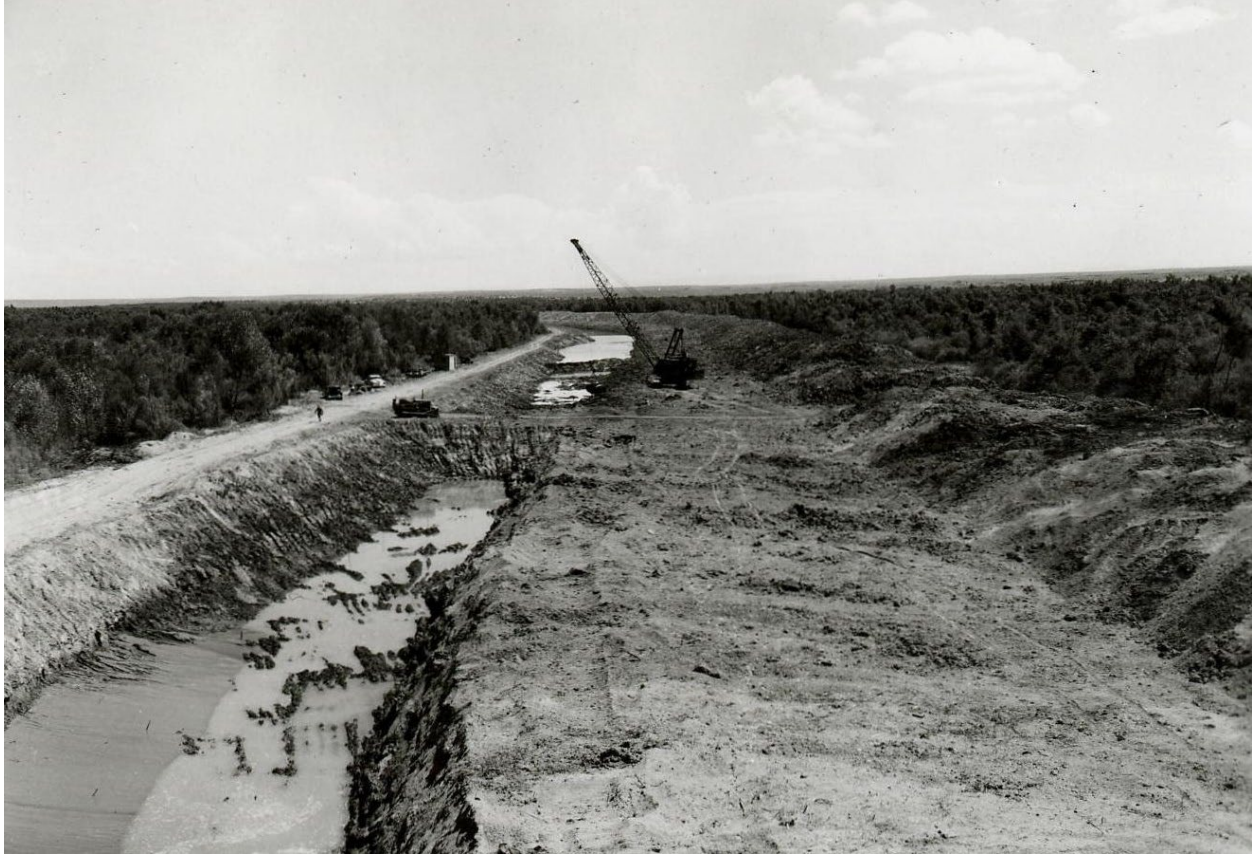
Figure 23.—Looking upstream at channel excavation operations, August 1952 (Reclamation/Herman E. Carter).

Channelization work on the Middle Rio Grande (Figure 22 and Figure 23) began as a result of a joint plan and report by the USACE and Reclamation to rehabilitate the river and existing irrigation works, and to lower valley water levels. Years of sediment buildup in the river channel and irrigation works resulted in high water levels water-logging agricultural lands and reduced capability of irrigation facilities to transport water (Gahan 2013). The river channel was discontinuous downstream of the BDA South Boundary (Figure 24 and Figure 25), and Reclamation estimated annual water losses in this area due to vegetation and evaporation in the floodplain of 195,000 acre-feet (ac-ft) without precipitation and inflow (Chapman et al. 1951) or 143,000 ac-ft including precipitation and inflow (Chapman et al. 1952). Chapman et al. (1951) estimated that the project would save 46,000 ac-ft per year and Chapman et al. (1952) estimated the annual water salvage to be 37,000 ac-ft per year. Water salvage estimates attribute most of the savings to lowering the groundwater west of the spoil levee to reduce transpiration from salt cedar. Congress authorized the project as part of the Flood Control Acts of 1948 and 1950.

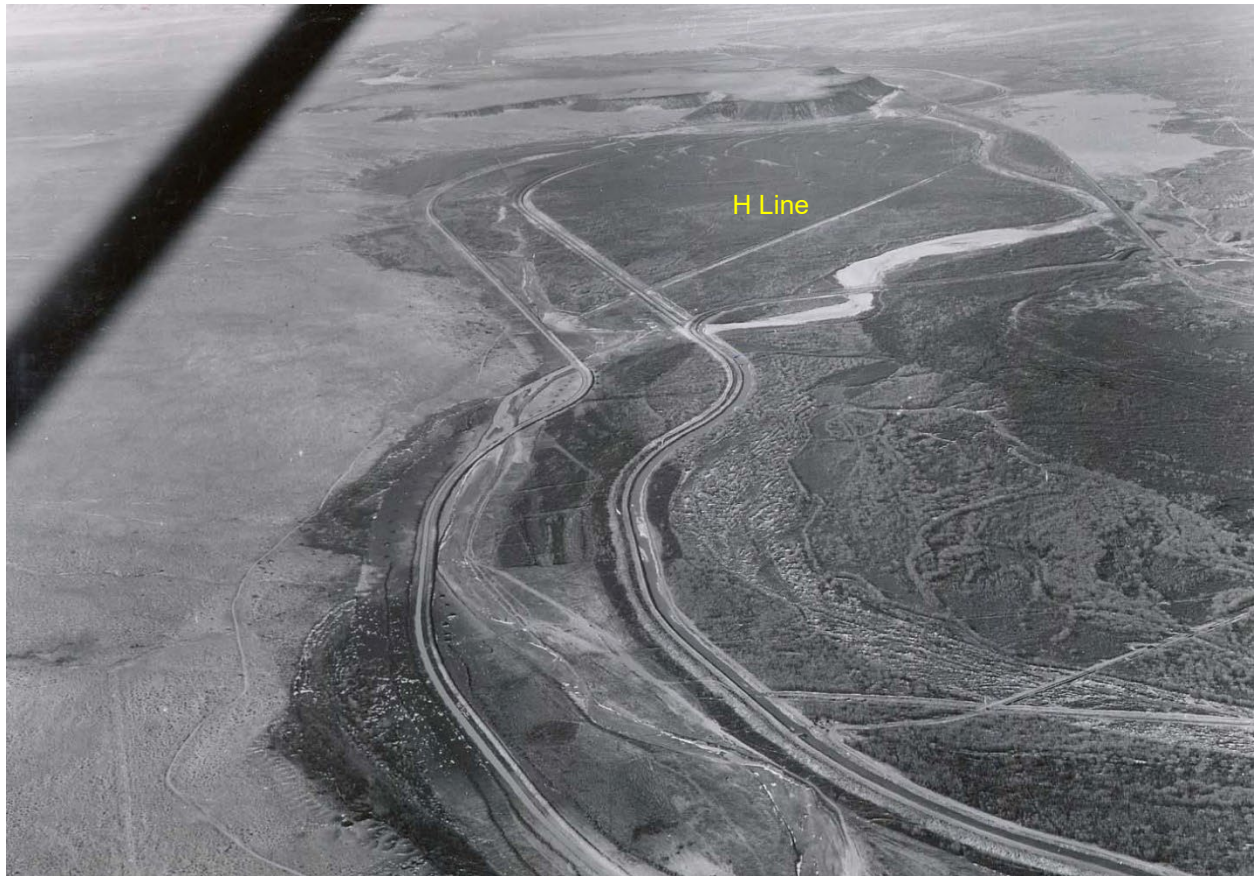
Figure 25.—Looking downstream toward San Marcial at floodway, levee, and constructed channel, December 1953 (Reclamation/Herman E. Carter). Entire flow of Rio Grande (300 cfs) is being carried by pilot channel in left of floodway. The “H Line” cut-off channel used during construction can be seen traversing the Tiffany basin.

To channelize the reach south of BDA, contractors first excavated cut-off channels to divert flow downstream and lower water levels to excavate the LFCC (see Figure 25, Figure 27). The LFCC and adjacent levee were constructed beginning with the Elephant Butte Narrows to San Marcial in 1951. Initially crews encountered difficulty with sloughing and sliding of the channel banks, heaving of the channel bottom, and levee subsidence due to areas of heavy saturated clays. To alleviate these issues the channel side slopes were flattened and berm widths were increased. Engineers found that draining the saturated soils before placement also helped with these conditions. Excavation of the BDA to San Marcial Reach began nearly a year later, with reports indicating low channel capacity and perching of the channel above the floodplain. The Narrows to San Marcial Reach was channelized by late 1952 and the San Marcial to BDA Reach was initially completed October 1953. Diversion of river flows to the LFCC at a heading structure near the BDA South Boundary (Figure 27) began in November 1953. Earthwork quantities for the initial channelization effort are shown in Table 1 and include excavation and vegetation clearing downstream of the BDA South Boundary (Reclamation 1951; 1952; 1953). Reclamation’s annual project histories do not describe the main river channel being excavated during the initial construction activities, only the LFCC construction and the floodway clearing. However, Figure 25 shows an excavated 1950s river channel east of the LFCC (left side of photo) in nearly the same location as the 2022 river (Figure 27).

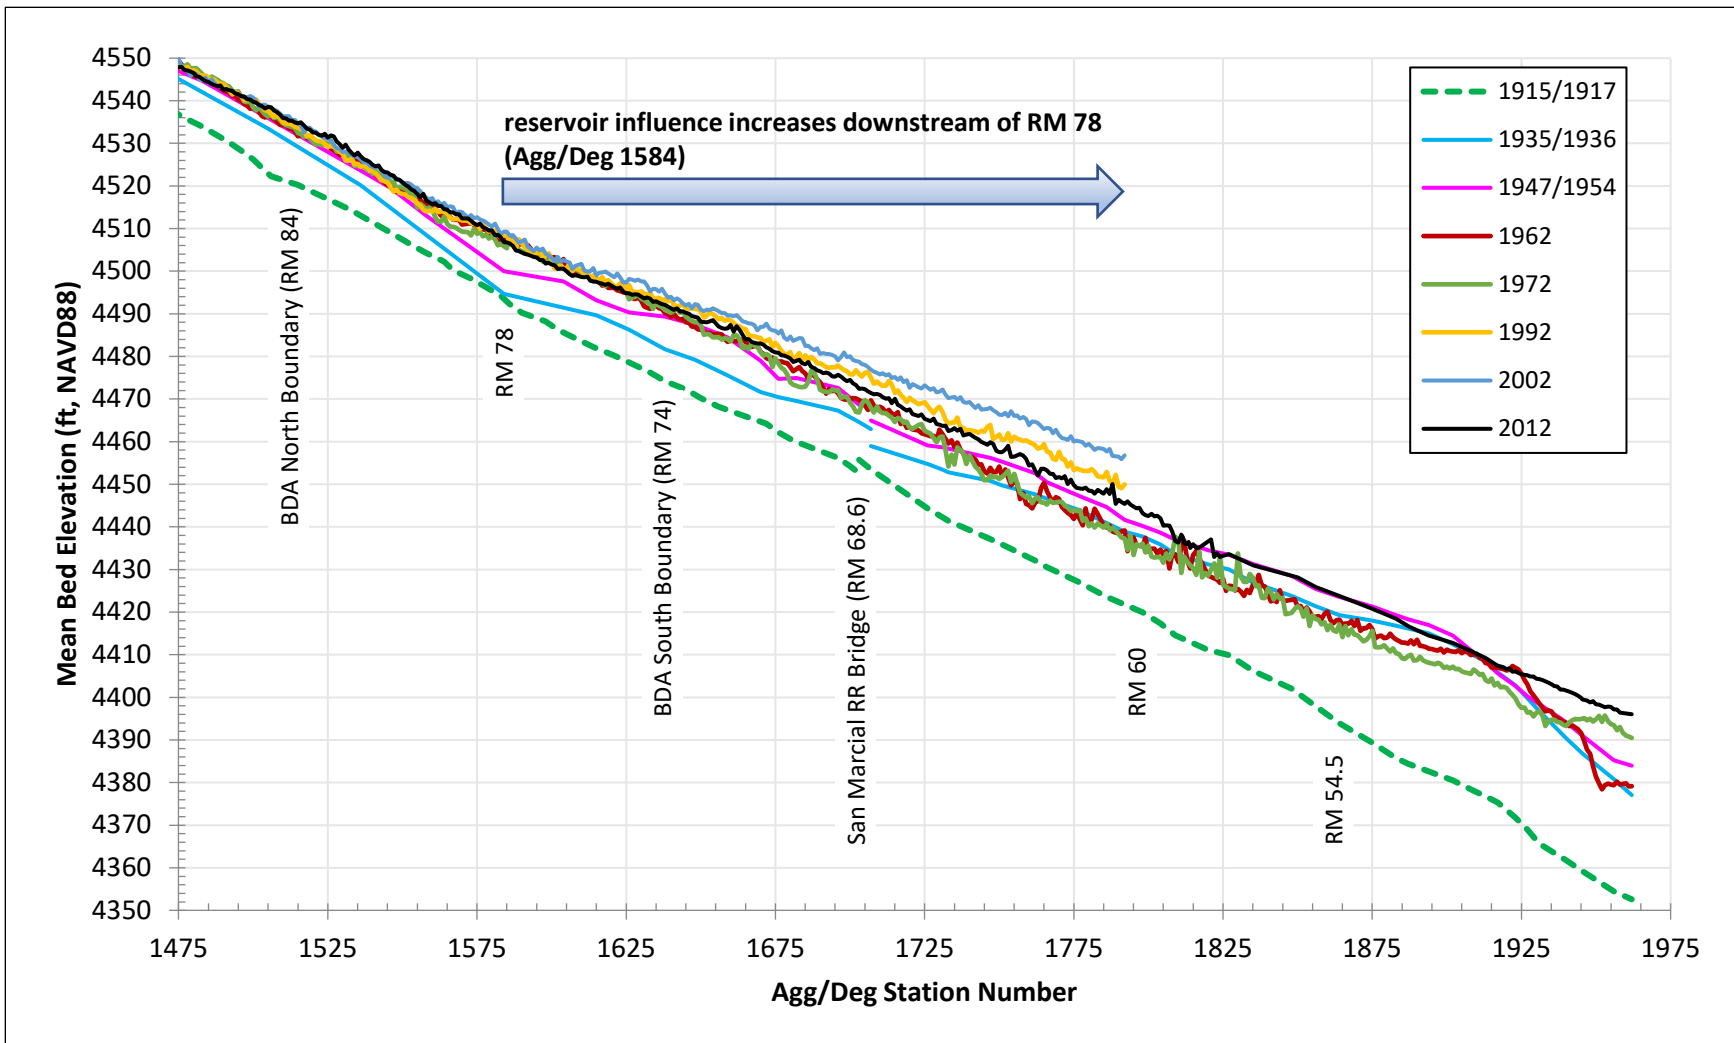
Figure 32.—Historical bed elevation profiles compiled from Elephant Butte Reservoir data (1915, 1935, 1947), digitized Soil Conservation Service cross sections (1936, 1954), Reclamation photogrammetry (1962, 1972, 1992, 2002), and Reclamation lidar (2012).

Bed elevation data for the project reach are available dating back to 1915 contour maps and 1917 surveys associated with the construction of Elephant Butte Dam. Figure 32 presents longitudinal profiles compiled from a variety of sources. The profiles show a consistent rise in bed elevation through 2002 and then erosion between 2002 and 2012. Changes between 1915 and 1935 represent the wedge of sediment deposition mostly caused by initial filling of Elephant Butte Reservoir. Profiles from years between 1962 and 2012 all converge near RM 78 (Agg/Deg 1584), about four miles upstream of the BDA South Boundary near the downstream-most LFCC check structure, indicating that the reservoir pool has the strongest influence downstream of this location. Upstream of RM 78, the bed has continued to aggrade, indicating a local sediment transport deficiency separate from the influence of the reservoir.

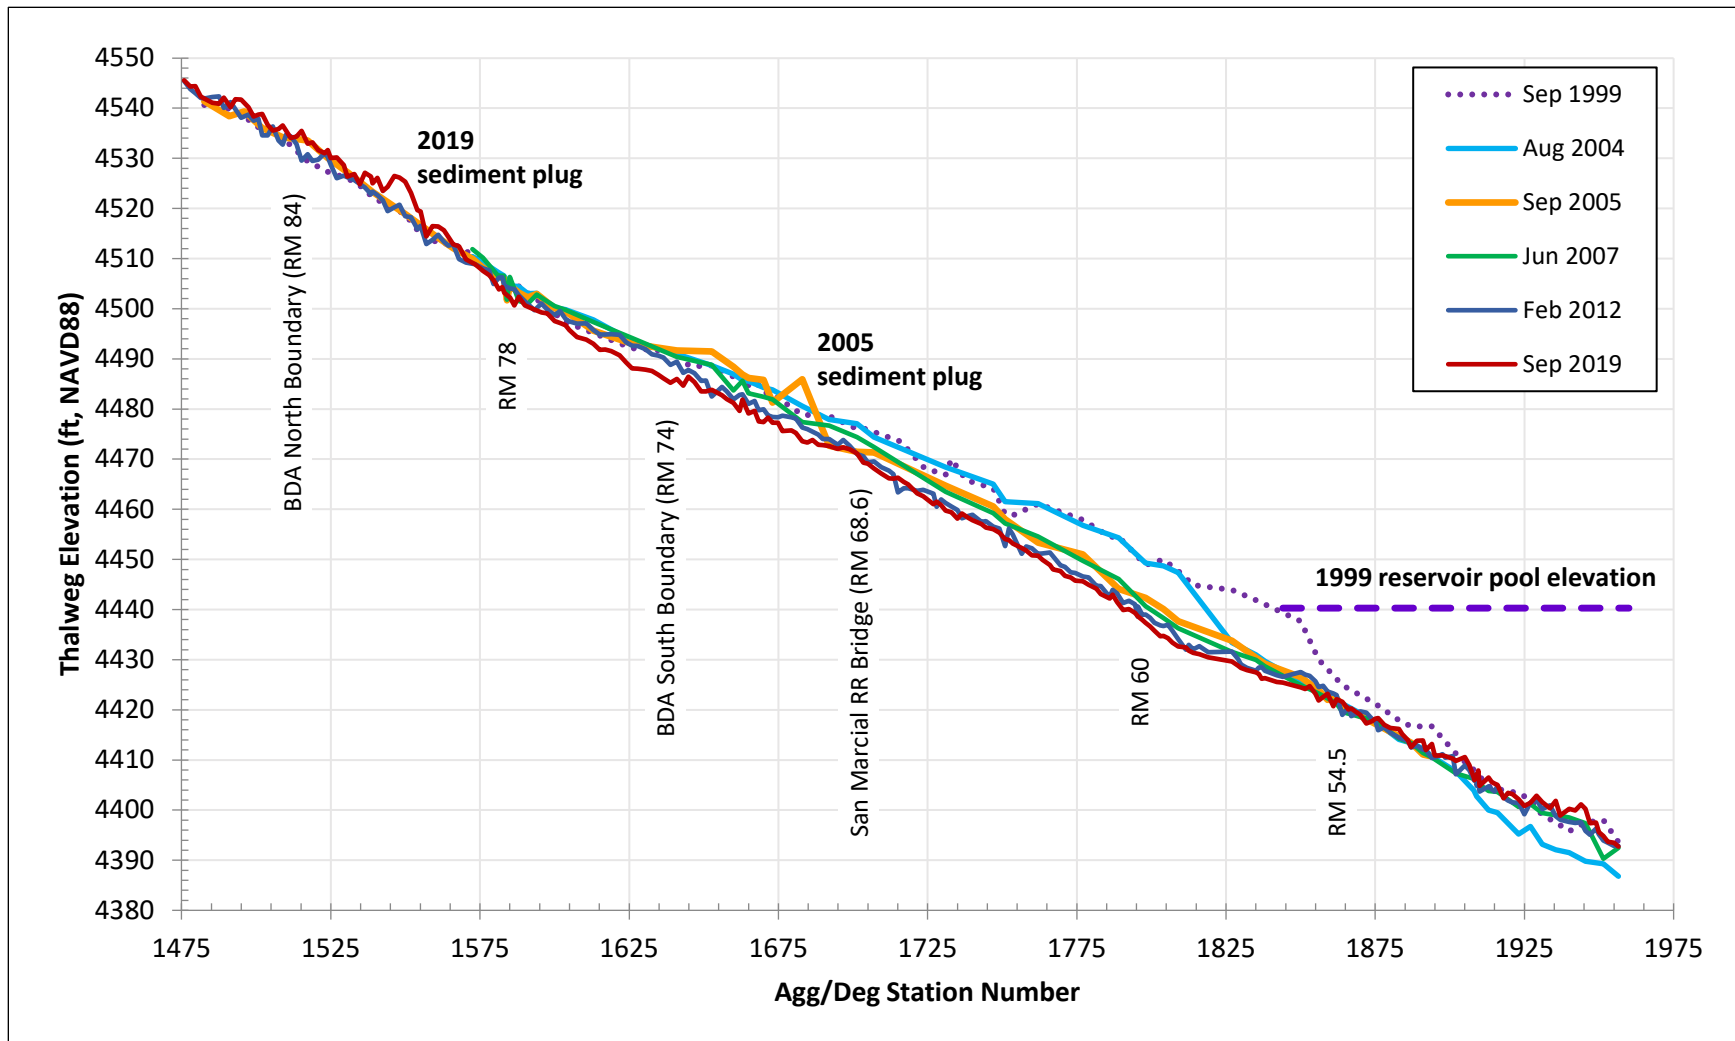
Figure 33.—Thalweg elevation profiles between 1999 and 2019 compiled from cross section surveys conducted by Reclamation contractors.

Thalweg profiles between 1999 and 2019 also demonstrate the influence of the reservoir while showing the local effects of sediment plugs (Figure 33). In 1999 the reservoir was nearly full, and the upstream backwater-induced aggradation extended to near the BDA South Boundary. The reservoir pool lowered at the onset of the drought in 2000 and a headcut formed that progressed upstream. In 2005, the river plugged with sediment near Agg/Deg 1675, which caused upstream deposition and downstream erosion. Sediment plugs essentially create a dam in the river that reduces the upstream slope and prevents sediment from moving downstream. Overbank flows that return to the river downstream of a plug are mostly clear water that erode the downstream bed. Removing the plug restores flow and sediment continuity so that the upstream bed erodes and the downstream bed deposits to resemble the pre-plug profile. Sediment plugs formed within BDA near Agg/Deg 1550 in 2008, 2017, and 2019. The 2019 profile shows that the BDA plugs had similar effects as the Tiffany plugs by causing upstream deposition and downstream erosion.

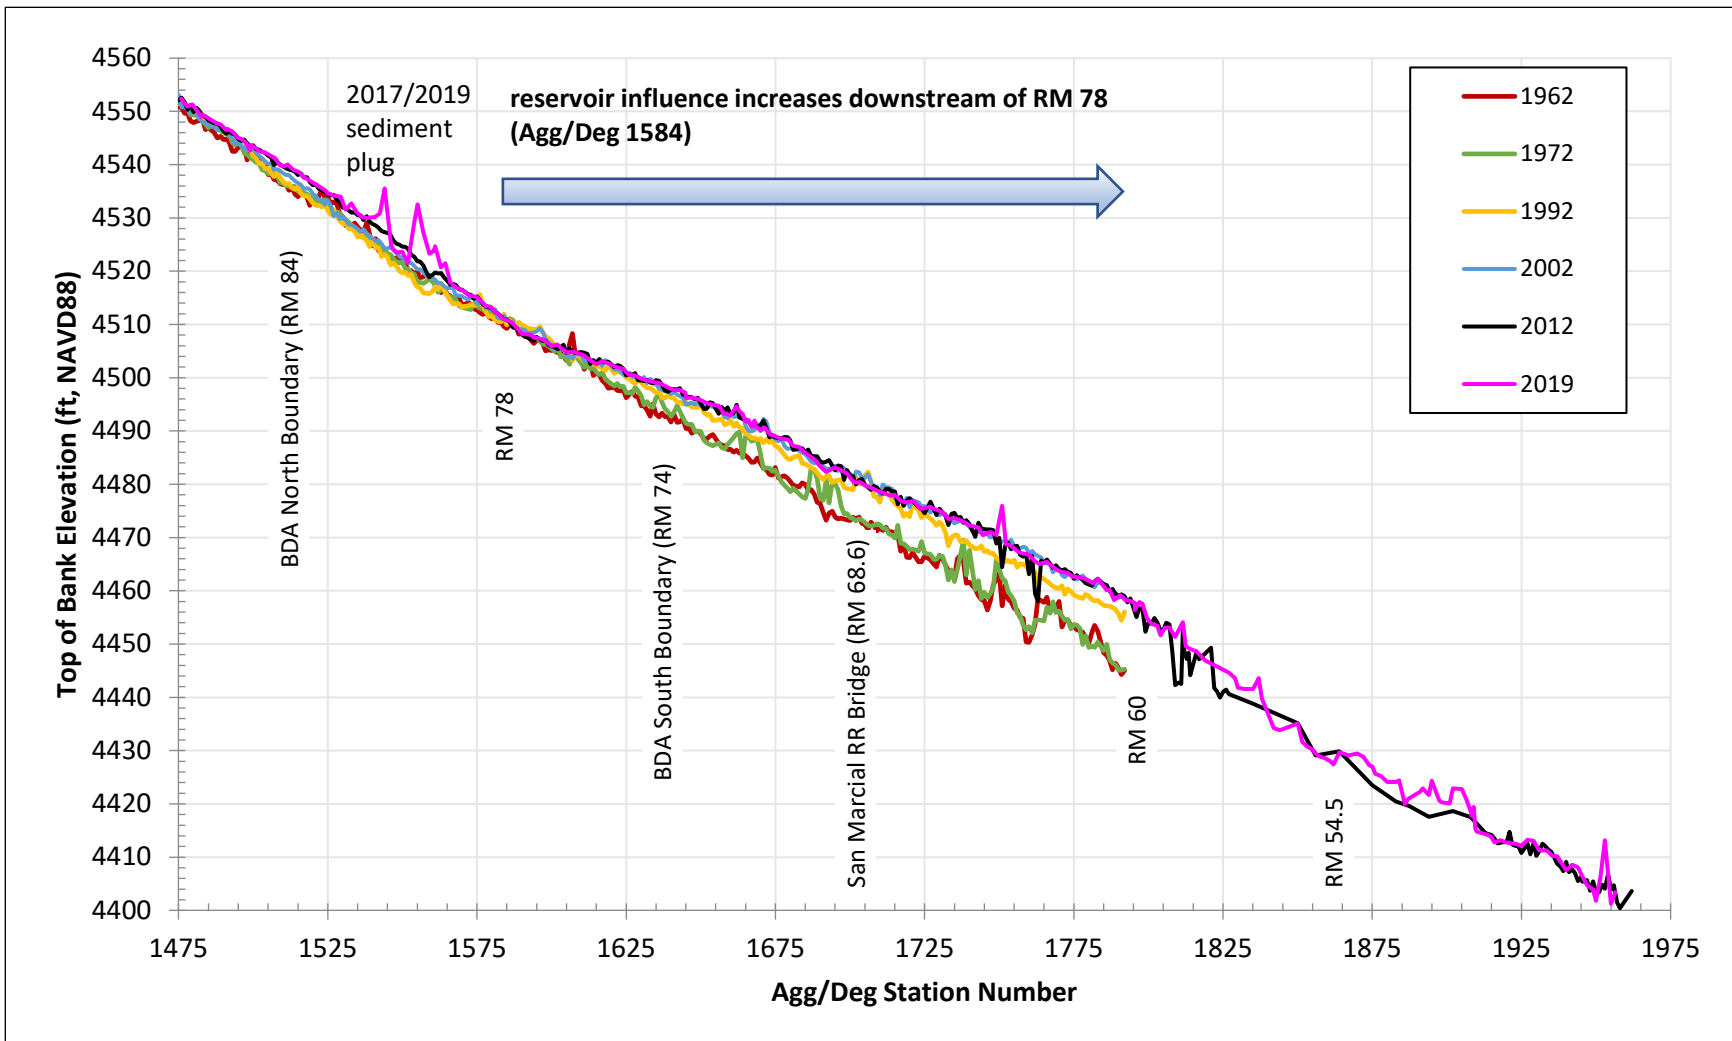
Figure 36.—Top of bank profiles over time, 1962–2019, calculated as average left and right bank elevation. Note increased bank elevations downstream of RM 78 (Agg/Deg 1584) due to the influence of Elephant Butte Reservoir.

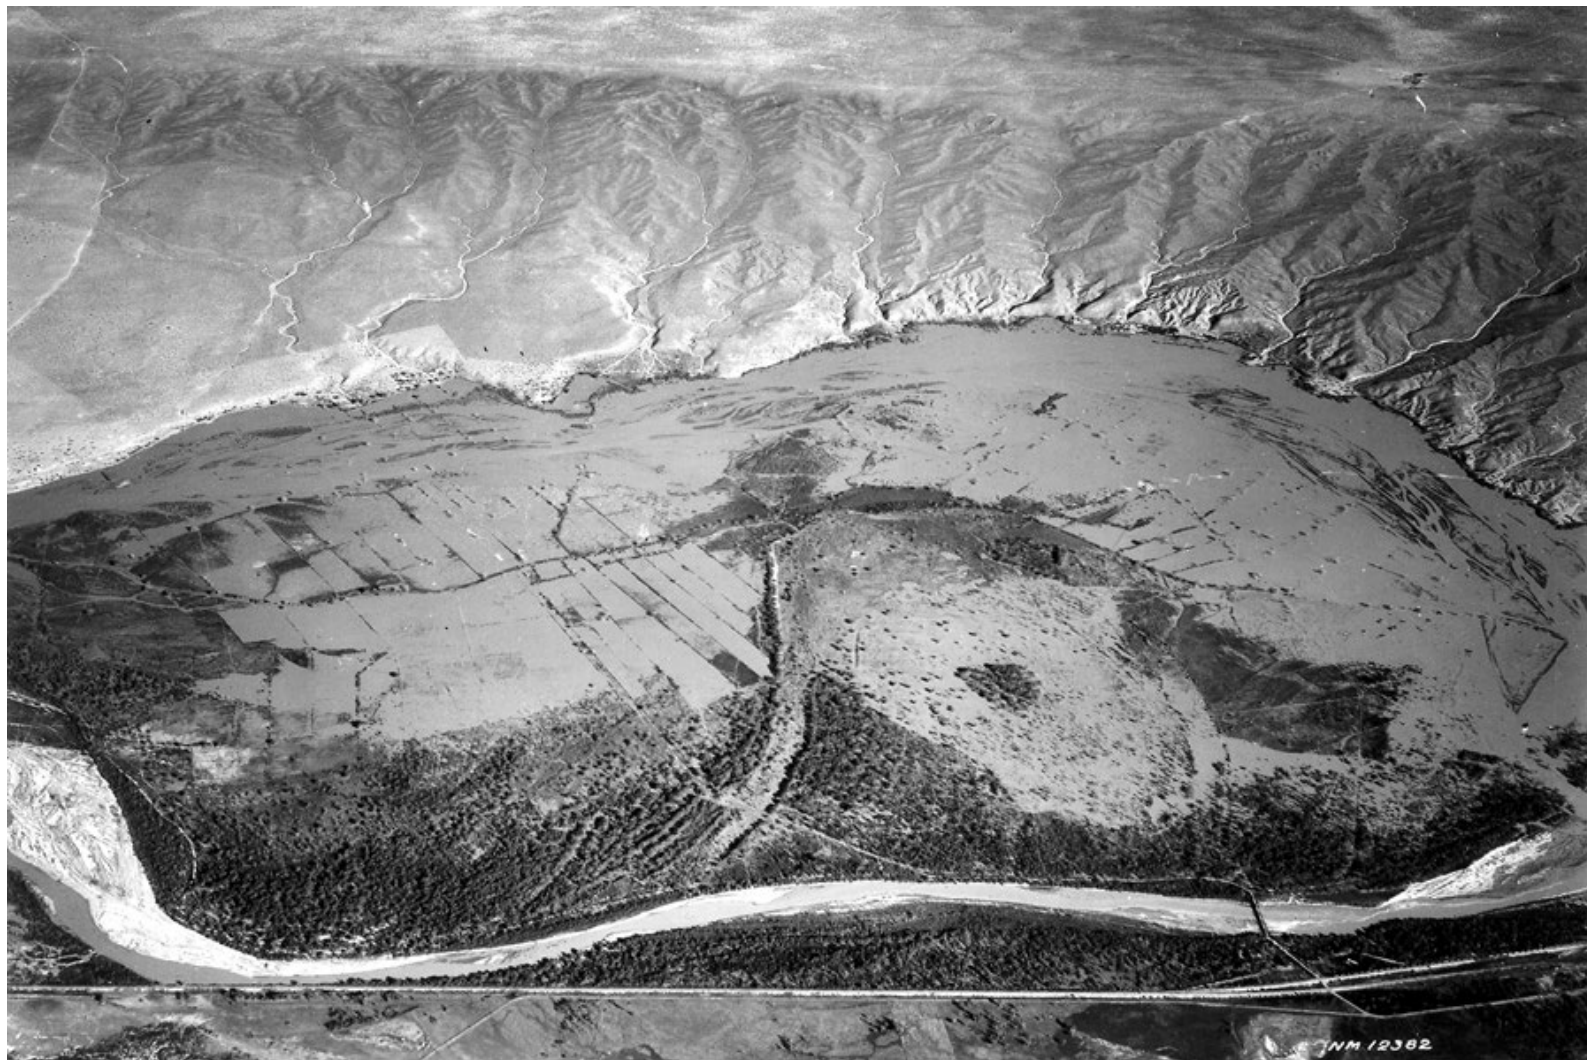
Figure 58.—Oblique aerial photo after the 1941 or 1942 flood looking southeast across Tiffany Basin with the San Marcial Railroad and the Rio Grande in the foreground (source unknown). Flow is left to right. Current channel location is in flooded area near the middle-top of photo.

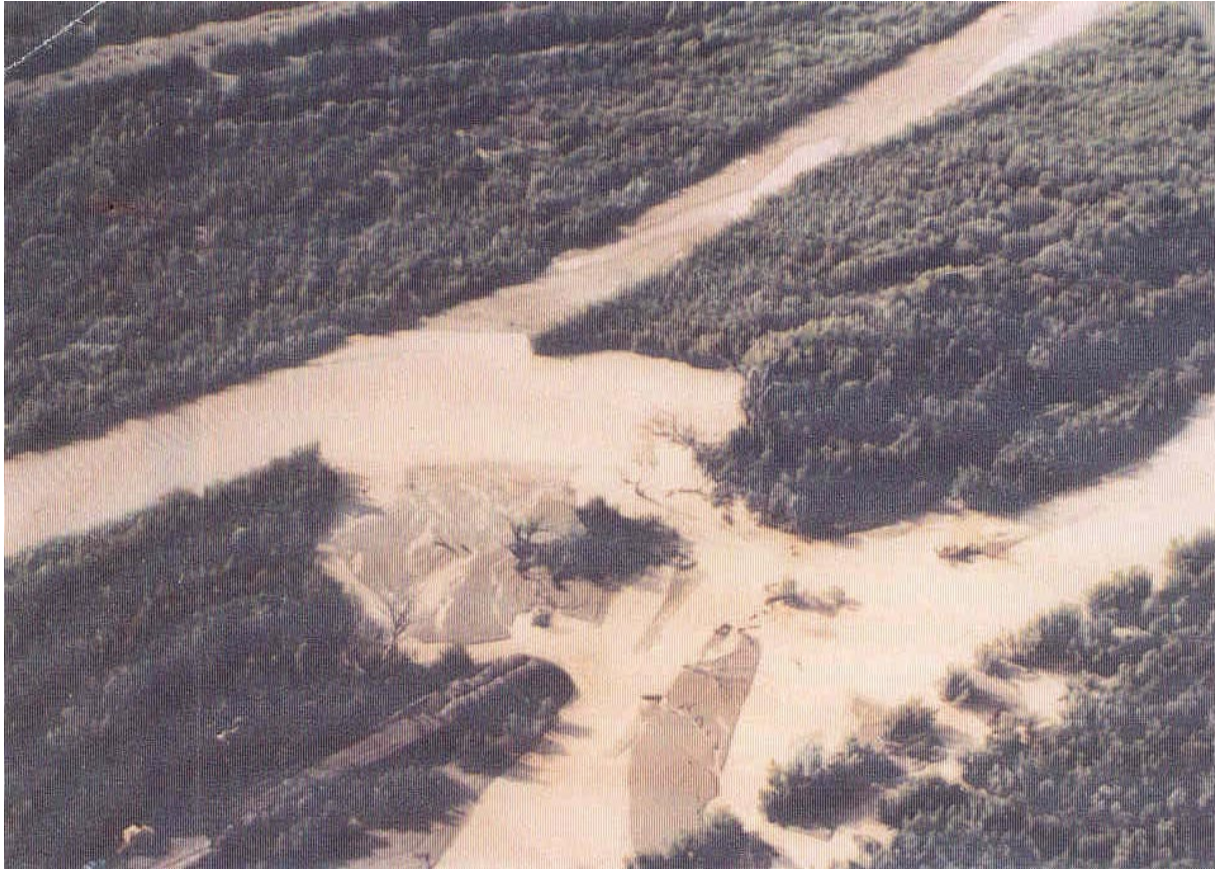
Figure 83.—Looking downstream at sediment plug and levee breach near RM 71.6 in 1991 (Reclamation/Drew Baird).

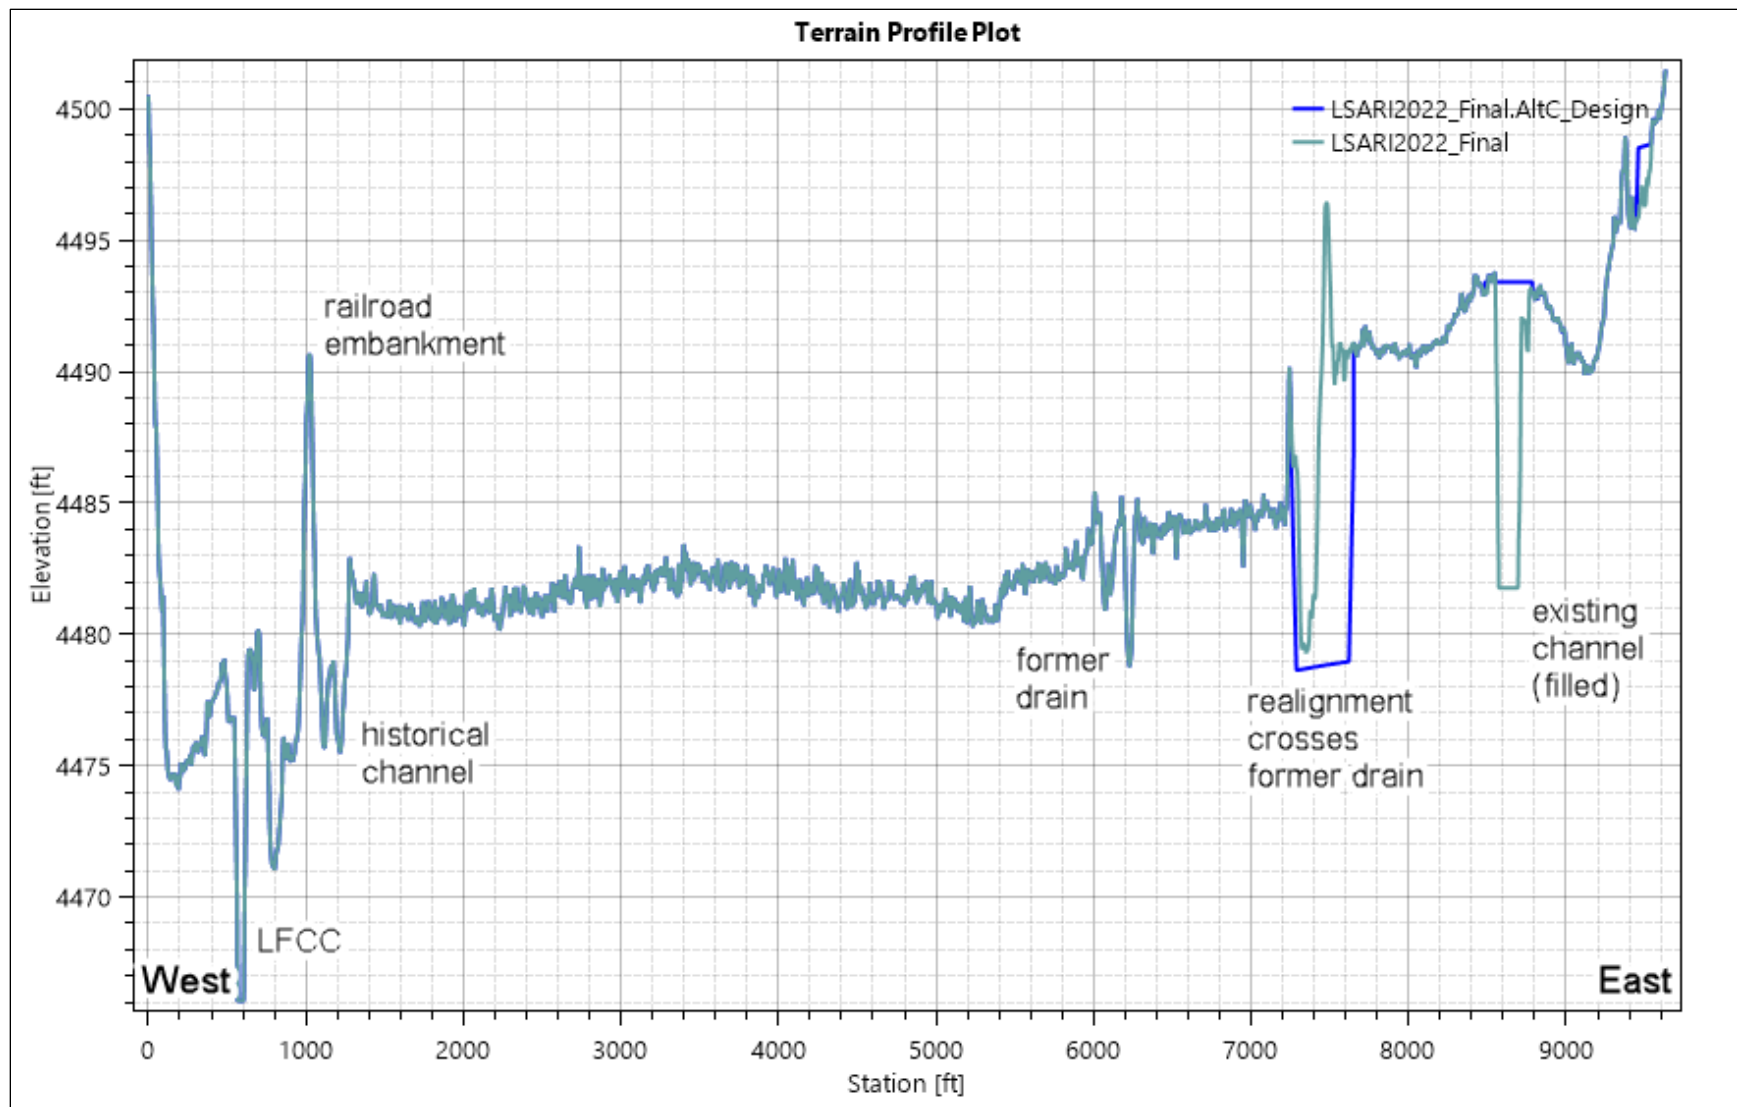
Figure 104.—Alternative C (dark blue) and existing ground (light blue) cross section looking upstream at RM 72.1.
